**MOWER COUNTY SOIL AND WATER CONSERVATION DISTRICT
DOBBINS CREEK WATERSHED PROJECT
STREAMBANK INVENTORY, 1993**

THOMAS R. BEDNAR

University of Minnesota Natural Resources and Environmental Studies Intern

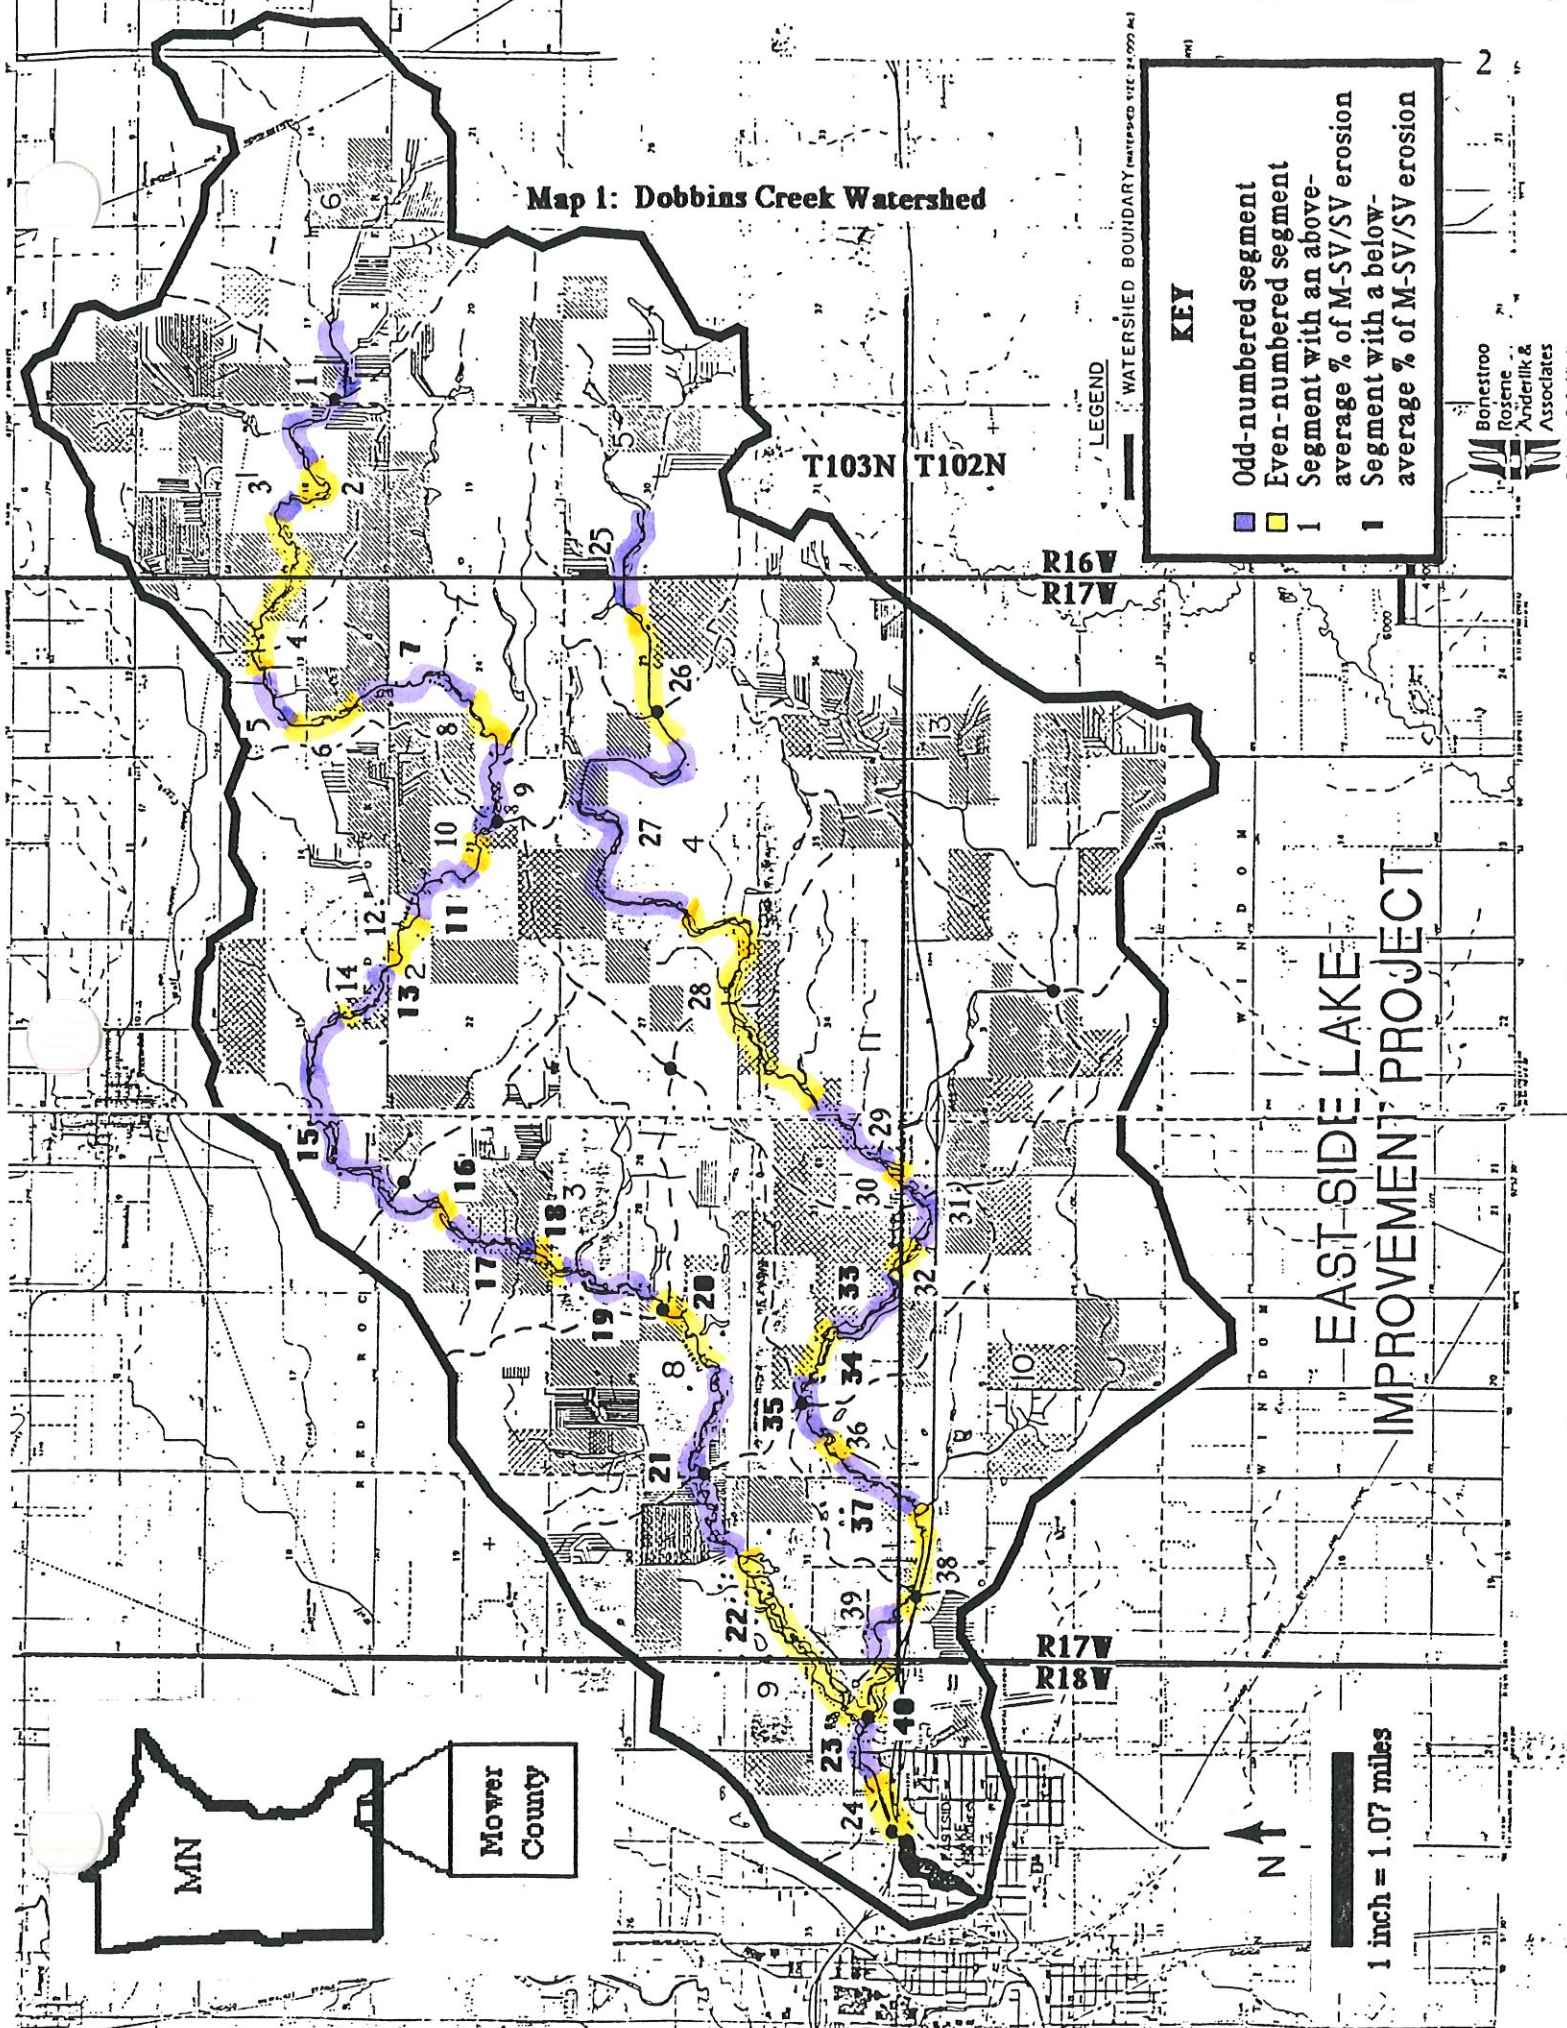
Map 1: Dobbins Creek Watershed

In addition, I subdivided stretches of fairly uniform riparian land use into 40 separate land-use segments (Map 1, page 2).

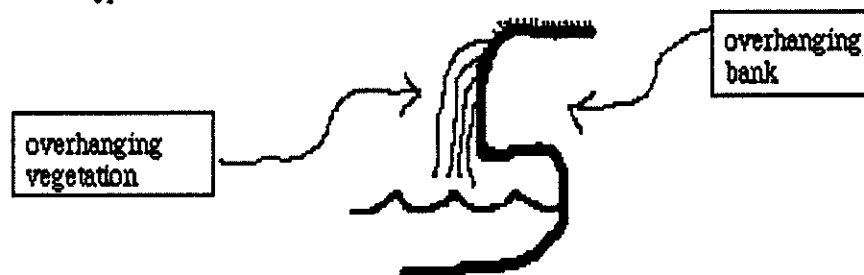
Figure 1: Type-a Bank

1. Type a: undercutting. This condition occurs when streamflow erodes away the bottom portion of the bank, creating a concave cavity that in many instances is hidden by overhanging vegetation.

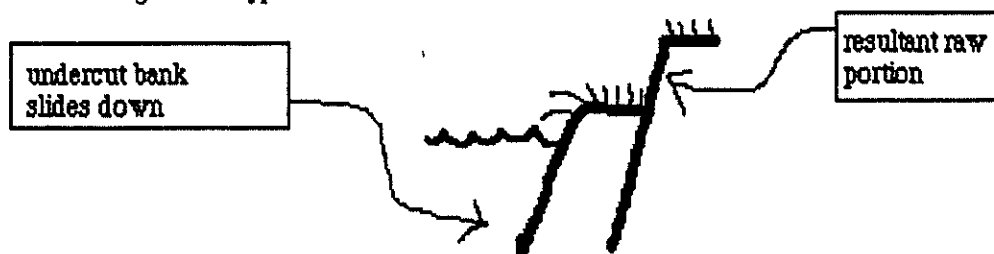
Figure 2: Type-b Bank

2. Type b: undercutting with upper bank sliding to waterline. Such banks, raw at the top, are relatively straight and steep.

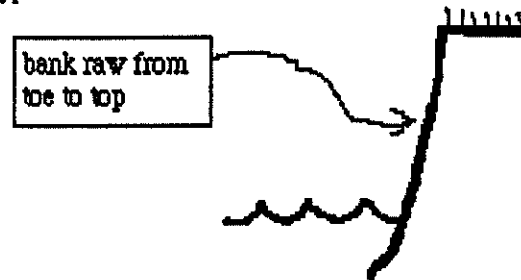
Figure 3: Type-c Bank

3. Type c: toe-to-top-of-bank erosion. This erosion type affects deflection banks, which accept the force of streamflow directly or nearly directly. Such banks are relatively steep and either straight or slightly concave.

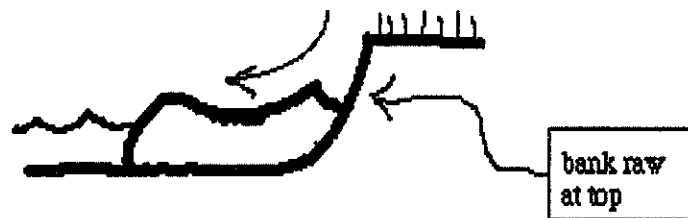
Figure 4: Type-d Bank

4. Type d: rotational slide. This condition results in the "internal failure" of the bank. As with Type-b erosion, the subsequent sliding of bank materials to the toe causes these banks to be raw at the top. This sliding, typically quite severe, also pushes the bank and bed materials at the toe up and out. Concave banks generally, but not always, at relatively low angles are the result.
