The New Cedar River and Turtle Creek Hydrologic and Hydraulic Model

Model Roll Out Meeting

January 10, 2012

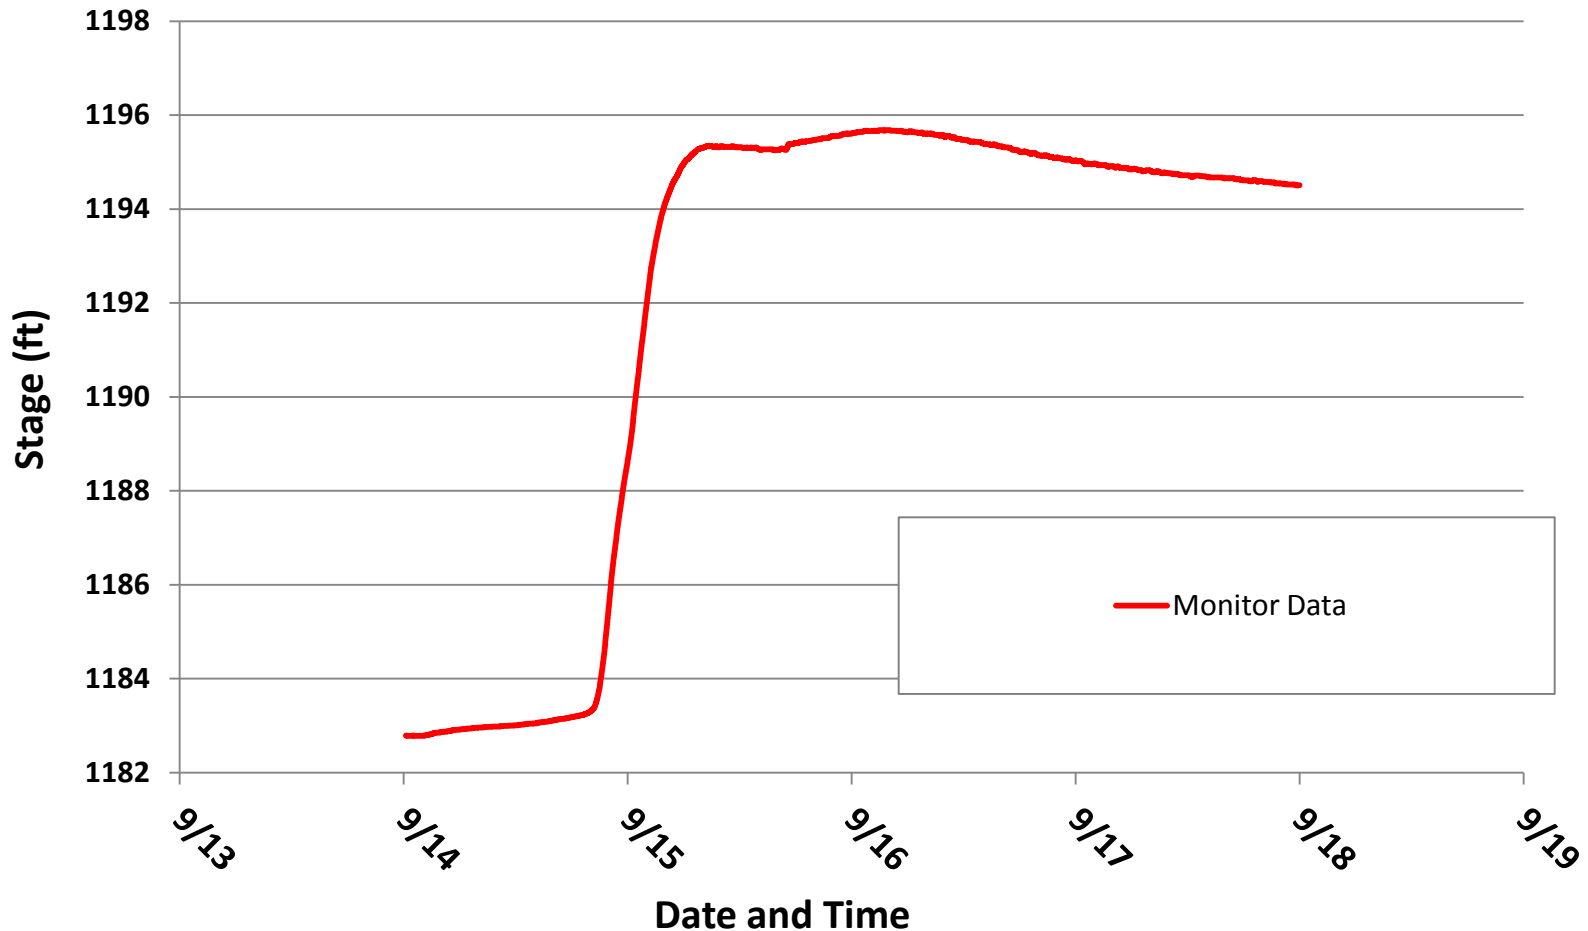
Measured Data (Monitored Data)

Gage 48027001 (Turtle Creek) – September 2004 Stage

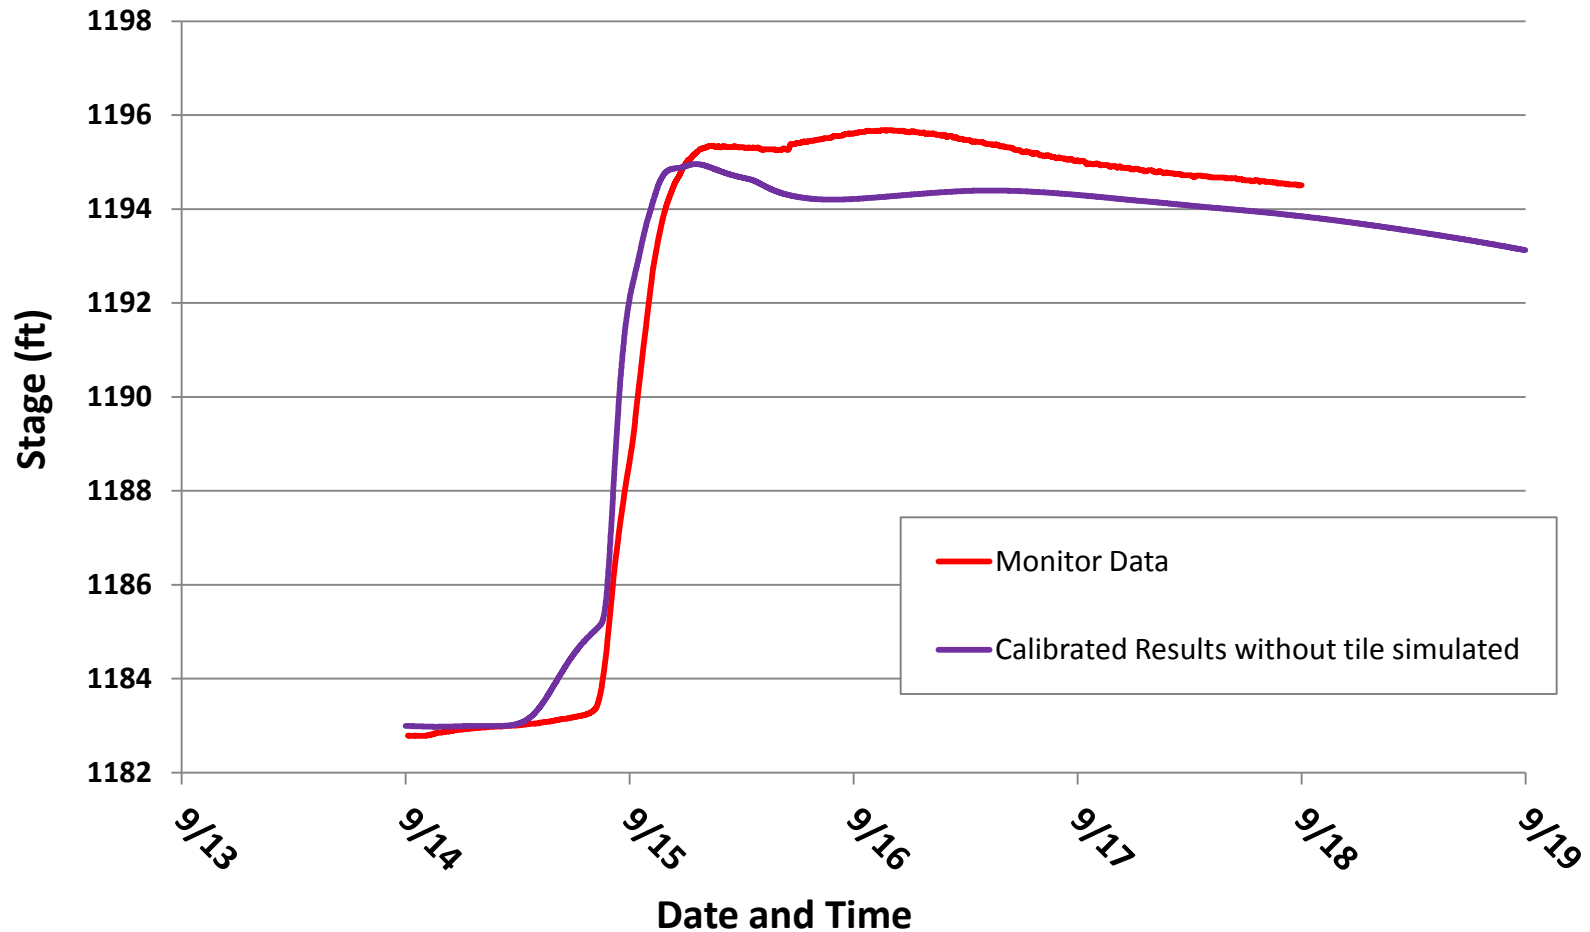
Calibrated Results

Gage 48027001 (Turtle Creek) – September 2004 Stage

- Then compare model results against actual measured flow gage data at various points in the watershed
- The published starting values typically need adjustments to make the modeling results more closely match the measured data
- These model adjustments are typically known as “calibration”

- We continue to adjust model inputs within the published range
- After each adjustment, modeled data is compared to measured flow gage data
- Additional adjustments are made until modeled flow data accurately resembles measured flow data

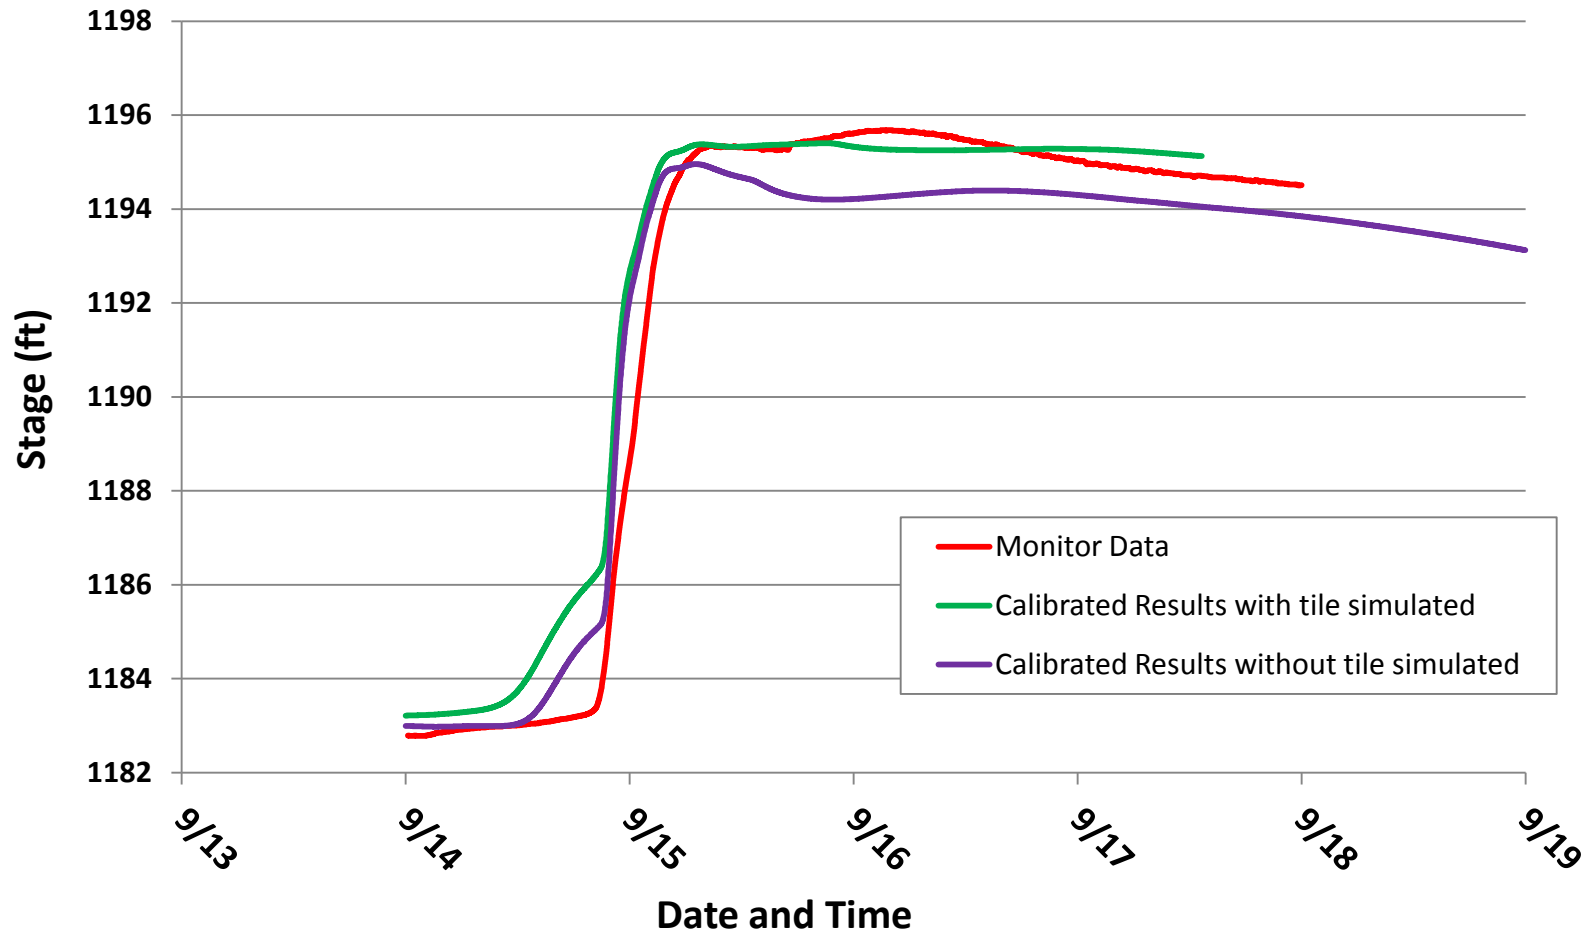
Calibrated Results – with and without tile simulated

Gage 48027001 (Turtle Creek) – September 2004 Stage

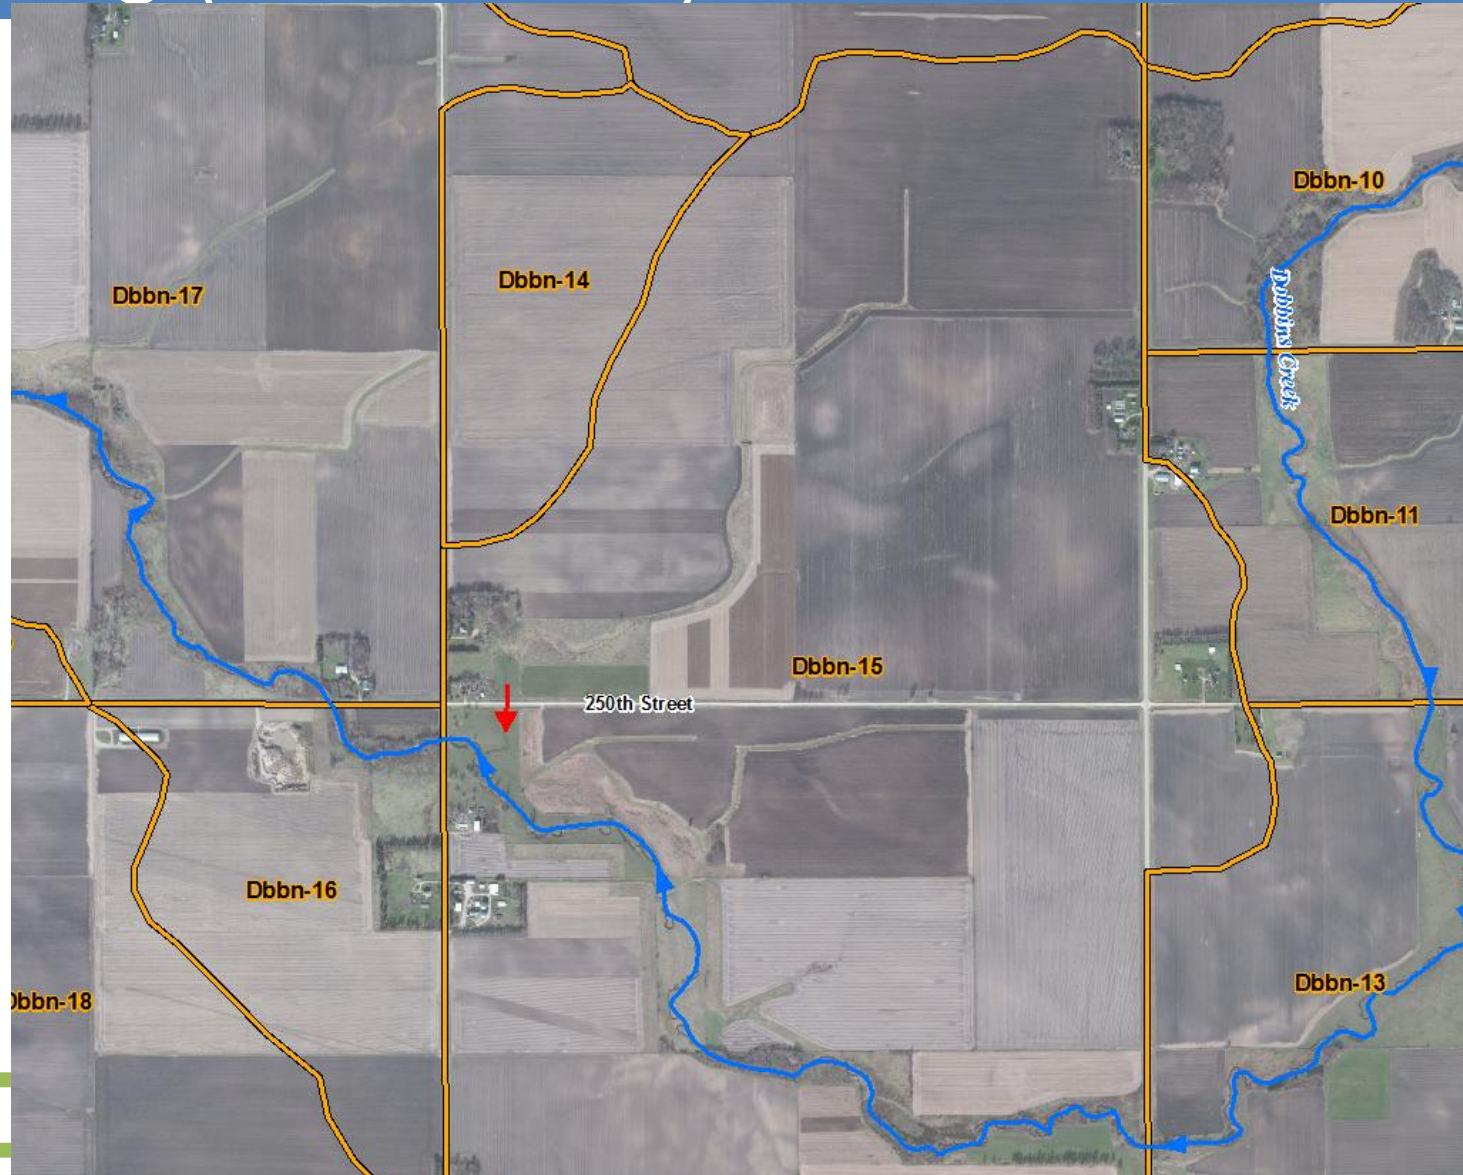
Example 1: Red Rock Township Road Crossing (250th Street)

- 250th Street was overtopping during large storm events
- Construction options discussed with township
 - Double culvert capacity
 - Raise the road
 - Restrict culvert capacity and raise the road and potentially see flood reduction benefits downstream
- Model results showed that road raise only was the best option.
- The analysis took about 10 hours
- Cost for this evaluation was about \$1,000
